Potential Projects for Flood Mitigation

TECHNICAL MEMORANDUM

RE: Canal Investigation Summary

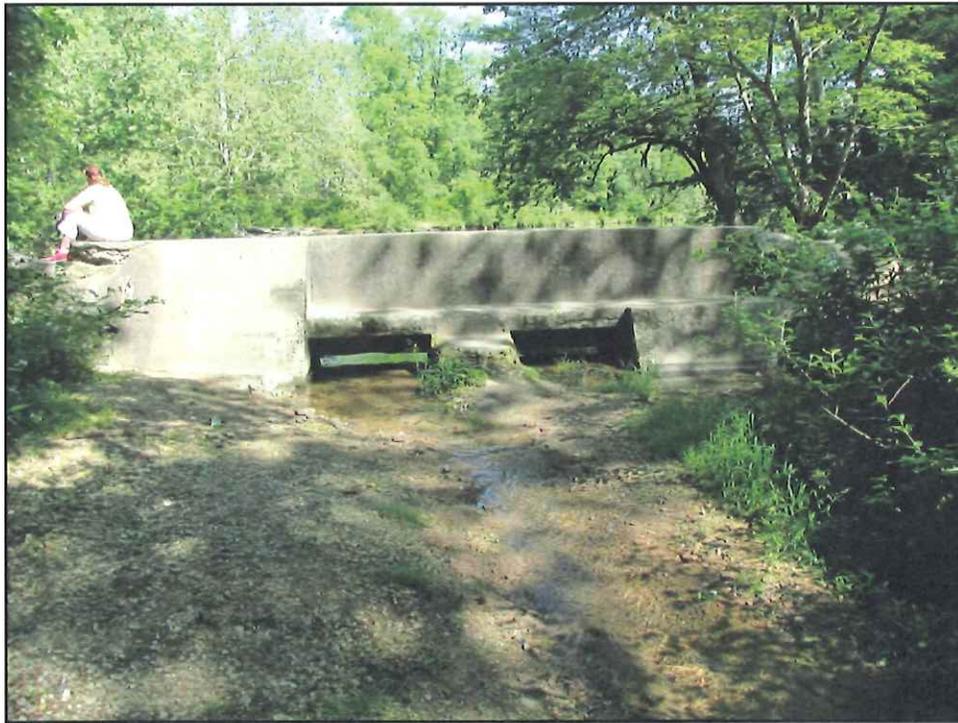
During the May 31, 2013 inspection, flow was observed entering the canal through the two square openings in the intake headwall (*Photo 3*). USGS Stream Gauge 01480700 upstream of Brandywine Dam located on the East Branch Brandywine Creek registered an average discharge

Photo 3 (05/31/13): Downstream End of Canal Intake (Looking Upstream)

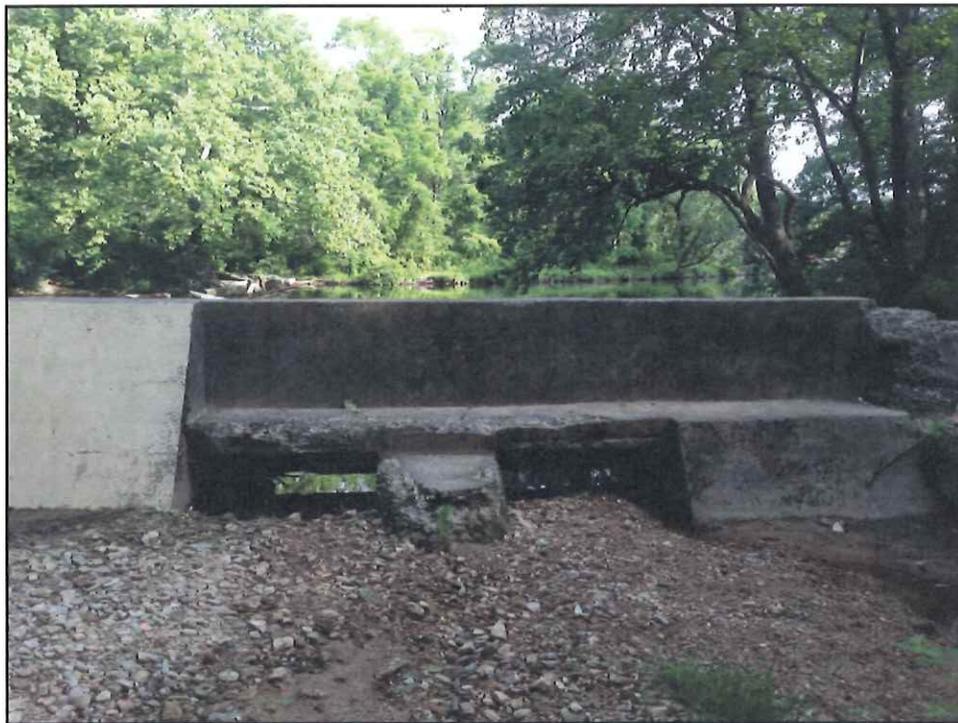
3. Accumulation of a significant volume of sediment and gravel deposits at the entrance to the canal and in the canal channel immediately downstream of the intake structure was observed to have occurred within the period between the two site visits. These deposits restrict the flow from entering into and flowing through the canal. It appears that sediment deposits will continue to be diverted into the canal from Ludwig's Run and East Branch Brandywine Creek during high flows while the dam remains.

Photo 4 (06/24/14): Downstream End of Canal Intake (Looking Upstream)
(Note Change in Silt Accumulation from 05/31/13)

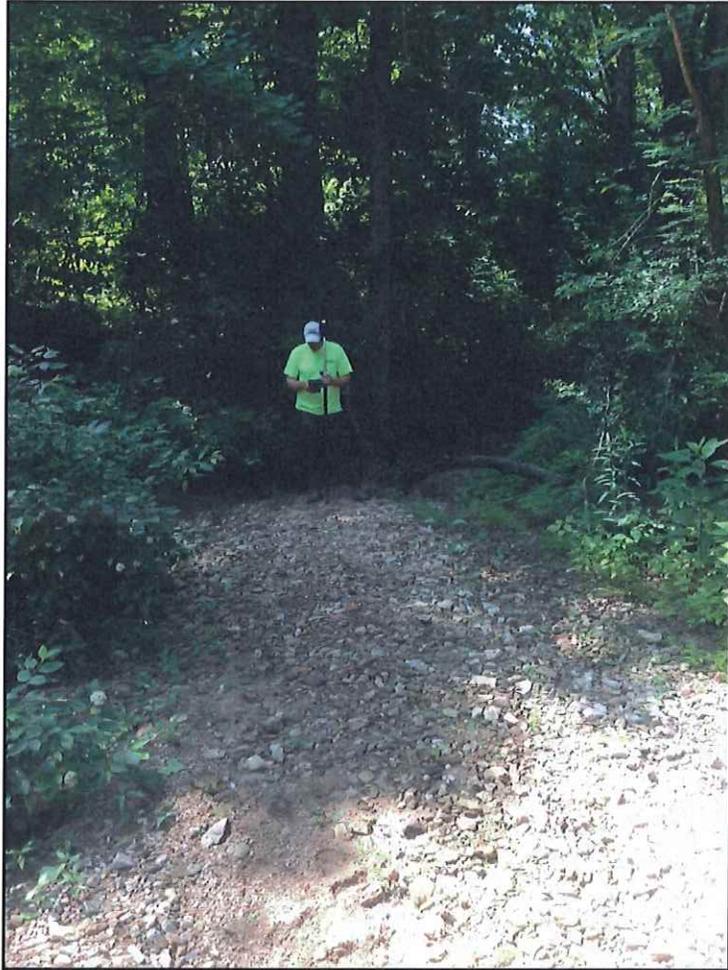
2. Bedload deposits (i.e. sediments and gravels) have accumulated throughout the canal resulting in: (1) near total blockage of the inlet openings to the canal from the East Branch Brandywine Creek, (2) loss of gradient through the canal to promote positive flow, (3) partial to total blockage of culverts under Route 30 and Norwood Road and, (4) continued bedload deposition, particularly at the inlet structure and in the canal channel immediately downstream of the inlet. Even if blockage is removed from the culverts, accumulated sediment along the canal and other features will restrict the capacity of the canal.

Photo 5 (06/24/14): Immediately Downstream of Canal Intake (Looking Downstream)
(Note Silt Accumulation)

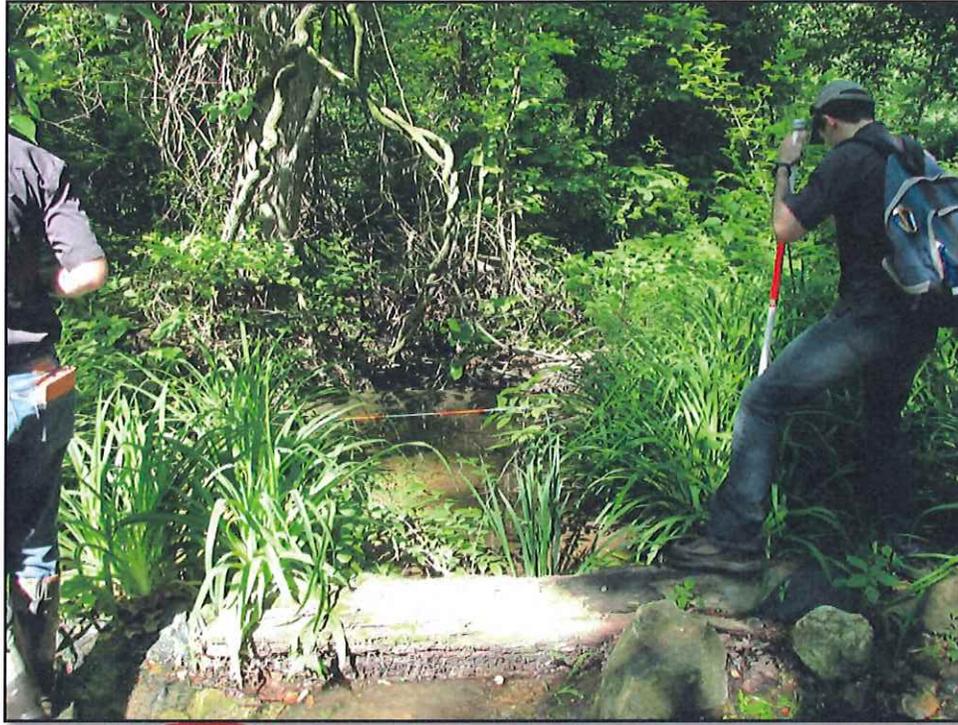
Approximately 170 feet downstream of the canal intake, the top of a concrete sill was identified along the right side of the canal channel, looking downstream (*Photo 8 and 9*). Flow was observed overtopping the concrete sill and returning to the East Branch Brandywine Creek on May 31, 2013. The top of the concrete sill was surveyed and determined to be at elevation 250.37 feet NGVD 1988. It is important to note that the concrete sill limits the amount of flow conveyed by the canal. Per the June 24, 2014 survey, the top of the concrete sill is only 0.15 feet (250.37 feet minus 250.22 feet) higher than the bottom of the canal intakes.

5. A shallow concrete sill located on the right bank of the canal approximately 170 feet downstream of the canal creates a low point along the canal sidewall that limits the flow conveyed by the canal by allowing overflow to discharge back into East Branch Brandywine Creek. Therefore, increasing the flow into the canal through the upstream intake would not materially increase the flow conveyed in the canal to the downstream lakes unless the concrete sill was raised or the channel was deepened along the entire length of the canal.

Photo 8 (05/31/14): Concrete Sill ~170-FT Downstream of Canal Intake

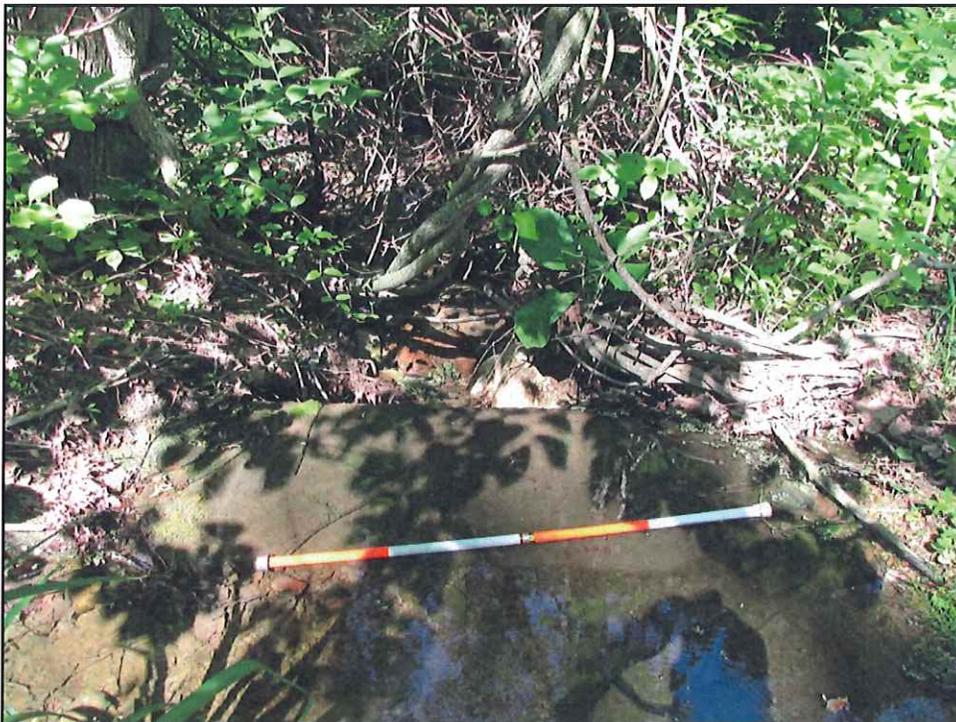
Photo 9 (05/31/13): Close-up of Concrete Sill

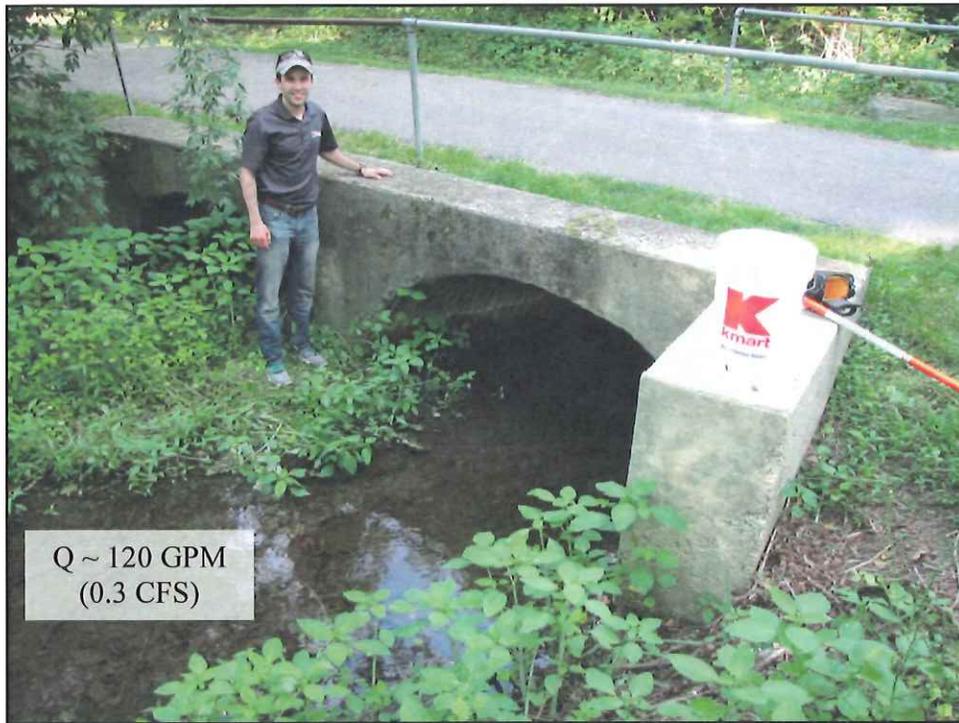
of approximately 95 CFS for the day. During the June 24, 2014 inspection, the bottom of the sediment filled intakes of the canal, as surveyed on June 24, 2014, were at approximately elevation 250.22 feet NGVD 1988. The same USGS stream gauge registered a flow of 80 CFS. No flow was observed entering the canal through the intake structure (*Photo 4*). A survey of the canal immediately downstream of the intake structure identified an approximately 6 inch deep deposit of newly accumulated sediment and gravel as comparison to the survey performed in July 2013 (*Photo 5*). The accumulated sediment and gravel appears to have been transported from a scour hole observed immediately downstream of the concrete slab beneath the Struble Trail bridge crossing over Ludwig's Run. On May 31, 2013 when flow was observed entering the canal, discharge in the canal was estimated by Gannett Fleming using approximate methods at the Struble Trail bridge, approximately 950 feet downstream of the intake, to be 0.30 CFS (*Photo 10*).

Q ~ 120 GPM
(0.3 CFS)

Photo 10 (05/31/13): Struble Trail Crossing Over Canal (North of Route 30)

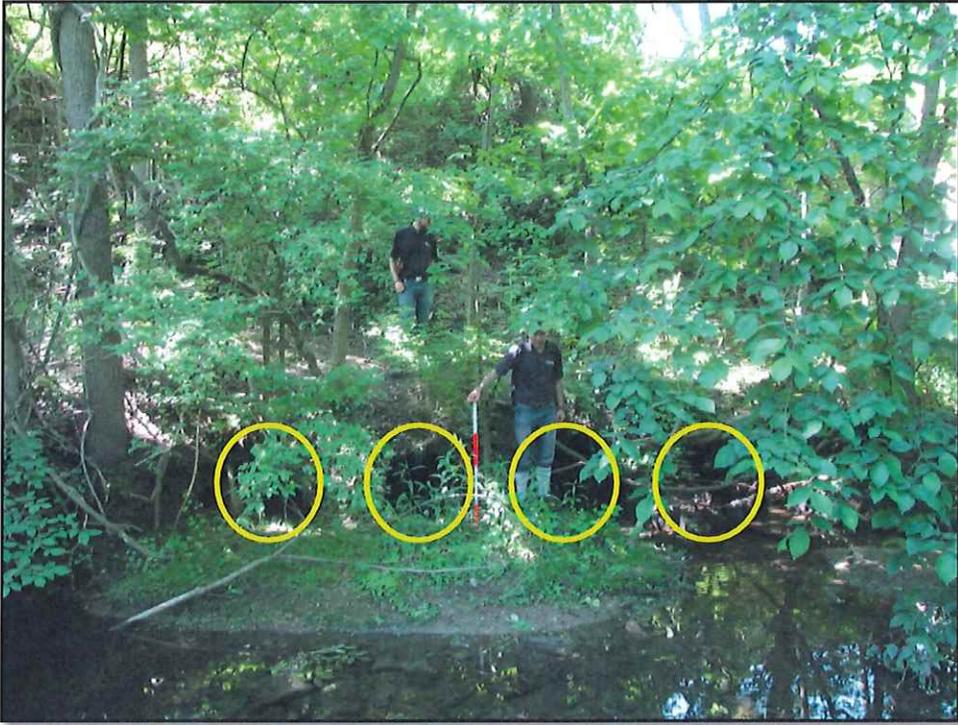
6. The culverts (four at the Route 30 road crossing and two at the Norwood Road crossing) that convey canal flow were observed to be partially to completely obstructed with sediment deposits.

Photo 12 (05/31/13): Corrugated Metal Pipe Culverts Beneath Route 30

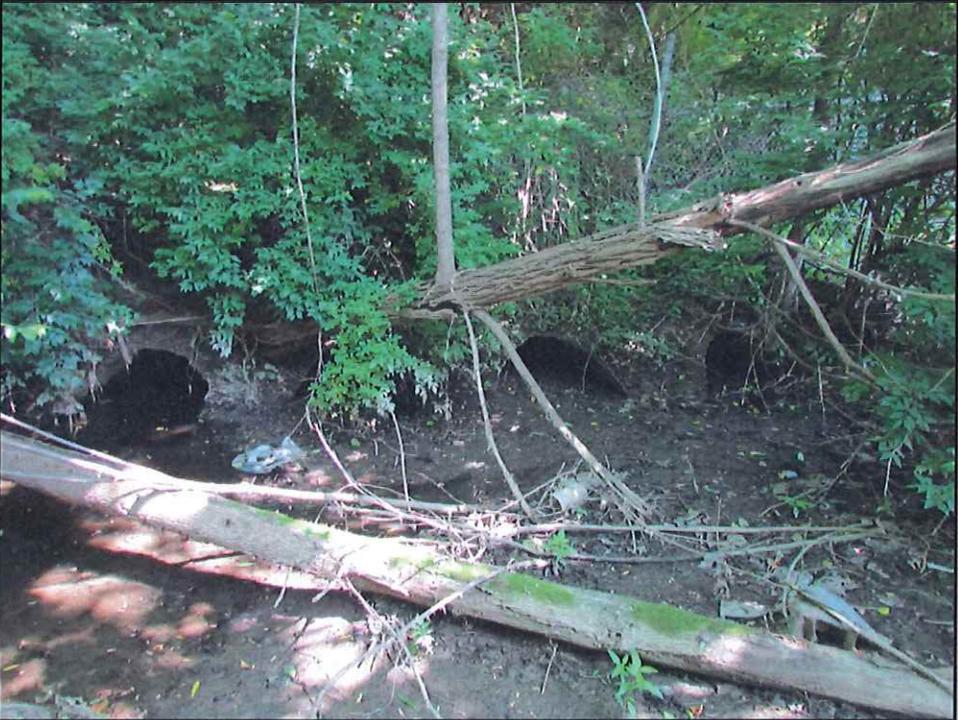
Photo 13 (06/24/14): Corrugated Metal Pipe Culverts Beneath Route 30

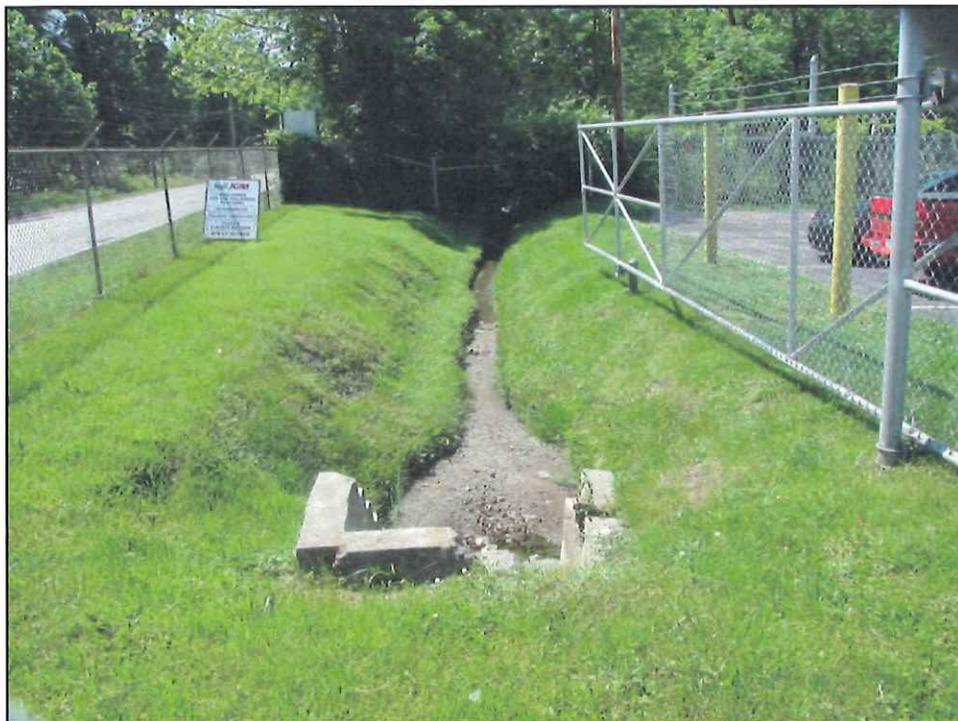
Standing water was observed in the canal from Route 30 downstream to the crossing at Norwood Road, on May 31, 2013 and June 24, 2014. A stormwater discharge ditch located adjacent to Norwood Road discharges into the canal immediately upstream of Norwood Road (*Photo 15*). Two concrete culverts that convey canal flow beneath Norwood Road were observed to have approximately 75% of their cross-sectional areas filled with sediment deposits (*Photos 16 and 17*). On May 31, 2014 flow was observed to be trickling into one of the conduits beneath Norwood Road (no flow was seen entering on June 24, 2014); no flow was observed exiting the conduits downstream of Norwood Road. Water was observed in the stretch of the canal from downstream of Norwood Road to Lake 5 on May 31, 2013 and June 24, 2014, however this water could not be distinguished from standing water or backwater from Lake 5.

Photo 15 (05/31/13): Example of Stormwater Discharge into Canal

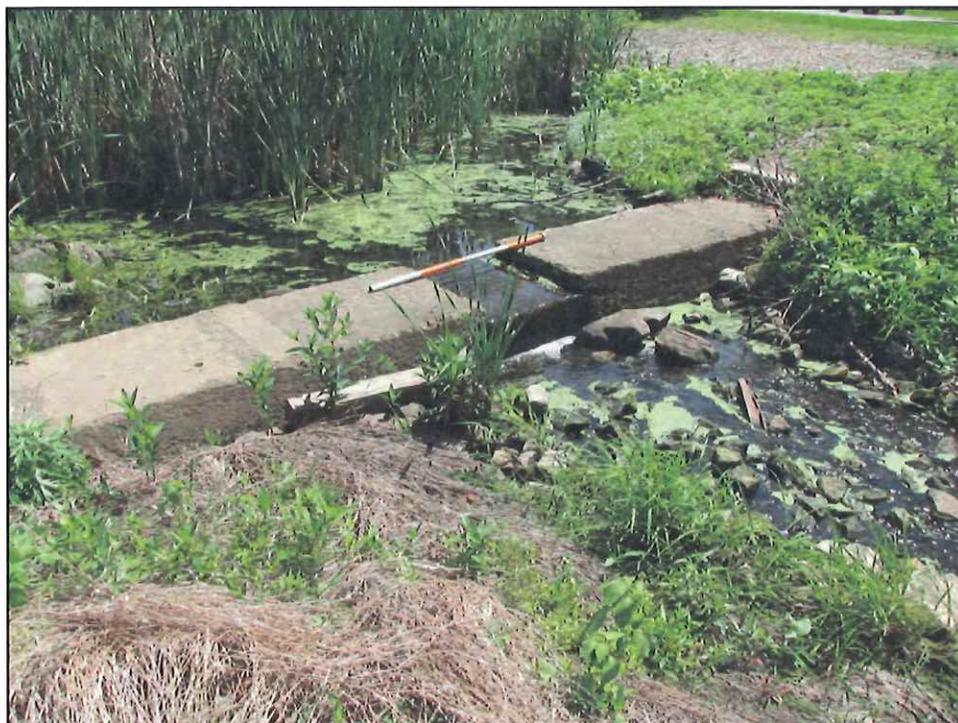
between Lake 3 and Lake 2. Lake 3 and Lake 2 may be viewed as a single lake with a contraction in the middle, instead of two lakes being connected by a canal. Water feeding Lake 3 and Lake 2 may include water from the canal, springs, surface runoff and groundwater interflow. Water from Lake 2 exits through a concrete weir (*Photo 19*) and continues downstream through two concrete culverts beneath East Pennsylvania Avenue (*Photo 20*).

Photo 19 (05/31/13): Weir Discharge at Lake 2

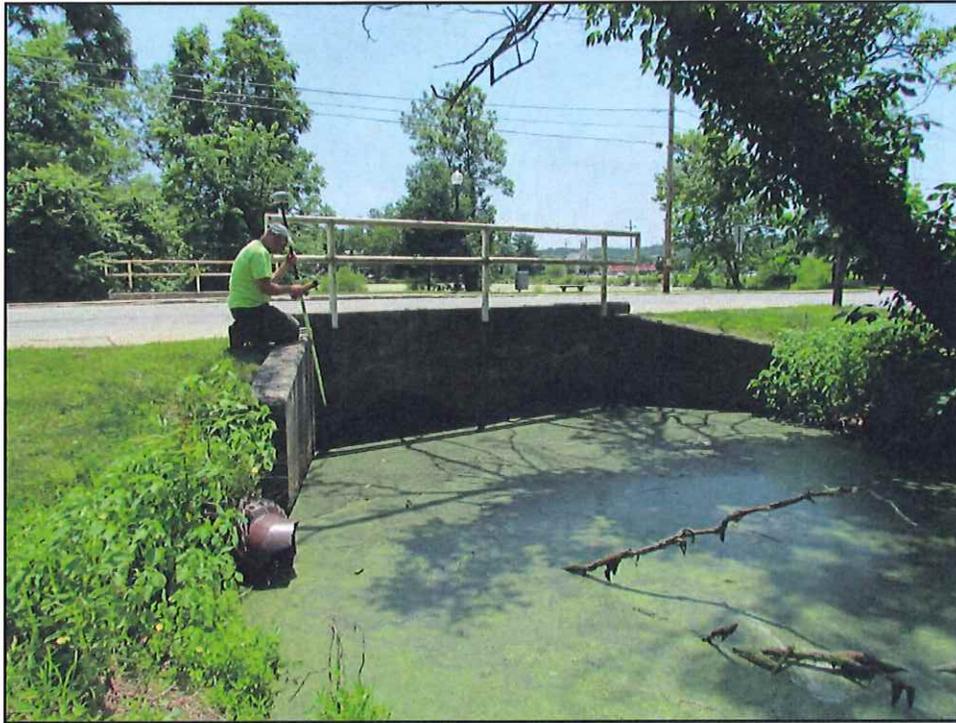
Photo 20 (06/24/14): Culverts Beneath E. Pennsylvania Ave.
